Inspection Report

Minerals Regulatory Program

Mine Name: DKG Quarry
Operator Name: Diamond K Gypsum

Permit number: M/015/041
Inspection Date: August 17, 2005
Time: 11:00 AM to 12:30 PM

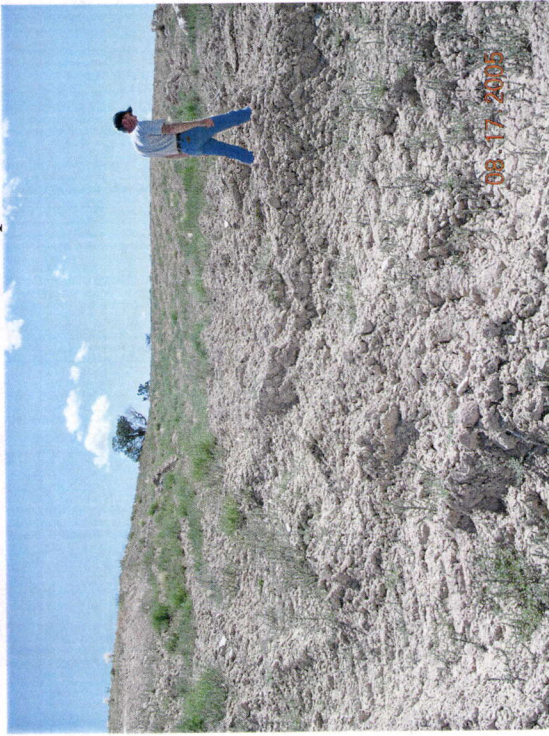
Some areas were reseeded for about the third time in 2004, and while there is an increased number of plants, there may not be enough to eventually achieve 70 percent of the cover in undisturbed areas. Mrs. Palmer and Mr. Henry asked whether these areas could be released based on Diamond K's efforts and rule R647-4-111.13.12. This rule says the Division can make a determination that revegetation has been completed within practical limits. As far as I am aware, the operator has done everything that was recommended by both the Division and the BLM. Before releasing these areas based on this rule, I would like to see if they progress enough over about the next year that they can be released with the normal success standard.

Photo 1 shows an area that was reseeded in 2004, and Photo 2 shows the area that was graded and seeded last fall. Most of the plants visible in these pictures are weeds because the seeded species are not yet large enough.

Photo 1. Area that was reseeded in the fall of 2004.

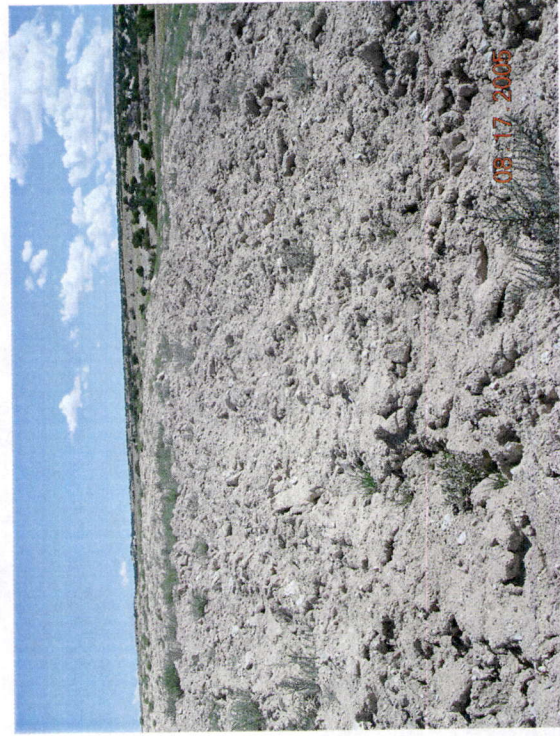
There is a moderate amount of vegetation in the area that was graded and seeded in 2004. There are a lot of shrubs, and I am optimistic these and the grasses will eventually provide adequate cover for this area to be released.

Photo 2. Area that was newly graded and seeded in the fall of 2004.

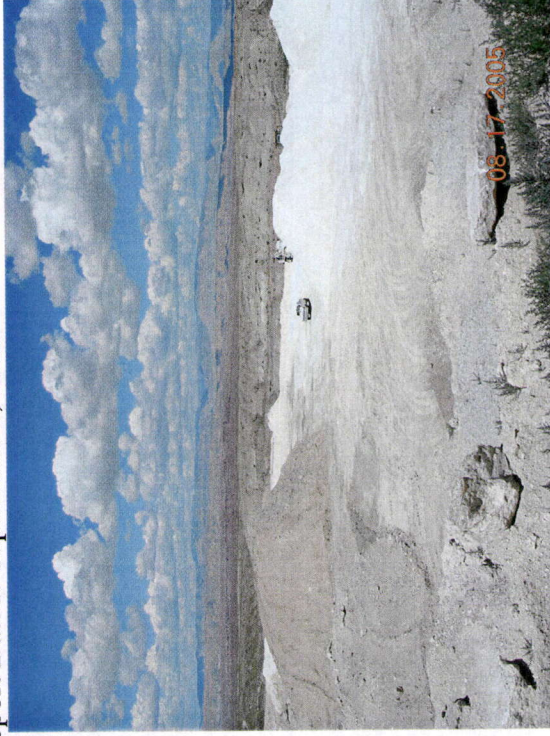
Photo 3. Overview of the quarry area.

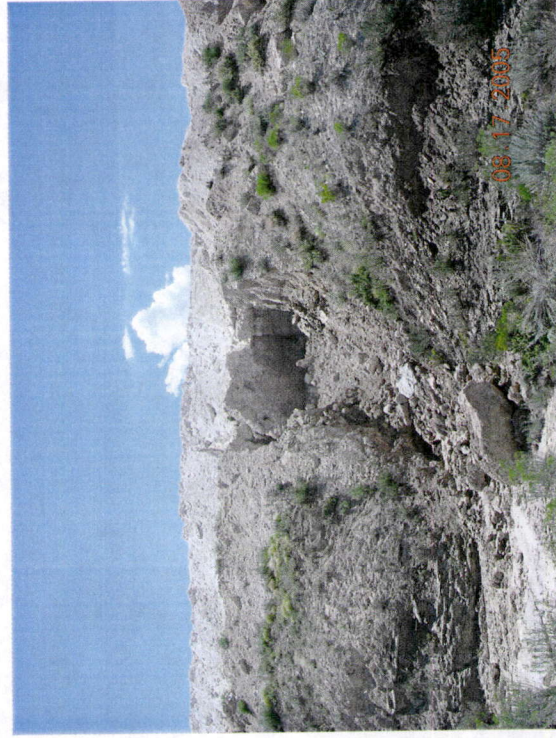
Photo 4 shows an area on the north side of the newly-opened quarry where there was a mass failure of fill. The operator mines on top of a small plateau, and there are several small drainages around the edge of this plateau into which overburden is placed. I believe drainage from the quarry piped into this fill and destabilized it. There has also been some erosion around the perimeter of the quarry.

Photo 4. A mass failure into Salt Wash from the outslope of the quarry.

The north side of the active quarry area needs to be graded to fix the piping, reestablish the berm, and to allow water to flow away from the slump. I suggest that runoff from this area be directed toward a depression on the west side of the mine which could serve as a sediment control structure.
